## PHASE I ENVIRONMENTAL SITE ASSESSMENT

### FORMER LANDFILL (TRACT 42) ST. PAUL ISLAND, ALASKA

**October 20, 2005**

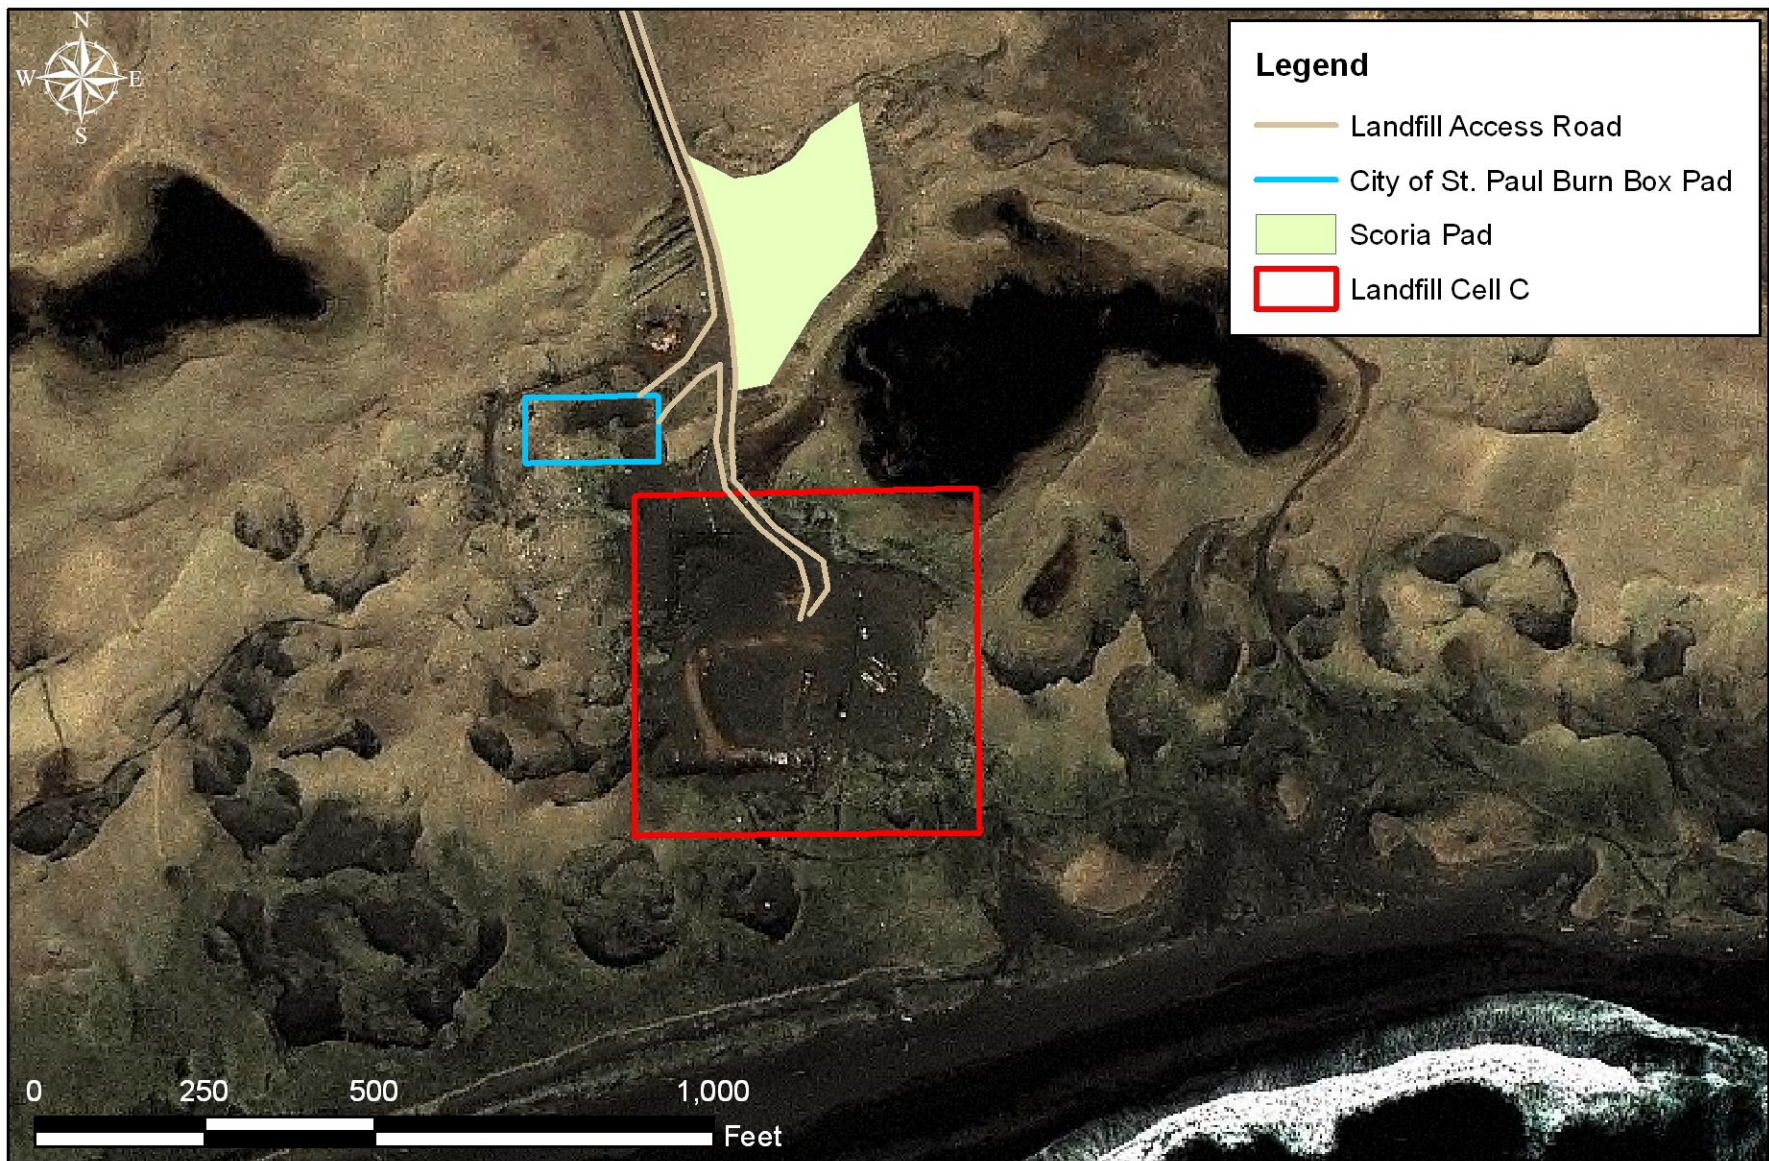
Figure

Subject Property  
Landfill Cell C  
St. Paul Island, Alaska

Sources: Landfill Cell C Boundary (BLM MTPs 1983), Burn Box Pad and Scoria Pad (Pribilof Project GIS 2003), Satellite Imagery (Ikonos 2001).

The subject property is located in the southcentral portion of St. Paul Island, south of the St. Paul Airport (Figure 2). The subject property is 5.78 acres in size and contains a closed landfill. The property also contains sand dunes. The subject property has a varied grade due to landfill use and closure activities, as well as natural wind erosion of sand dunes.

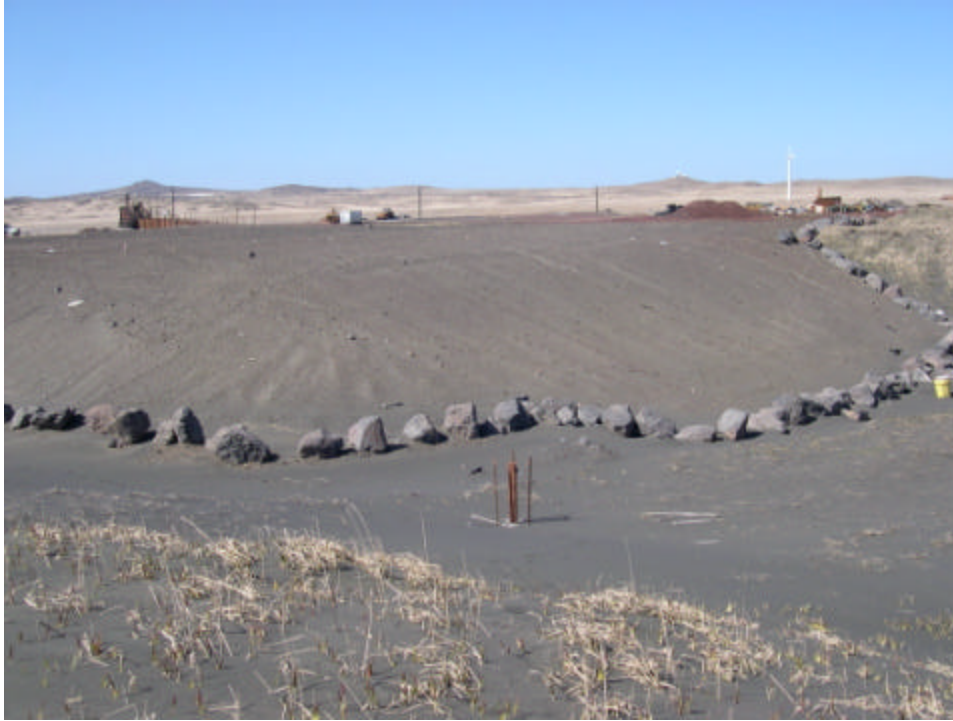
Photo 1. Former Landfill (Tract 42). Looking From Southeast to Northwest. NOAA. May 2005.

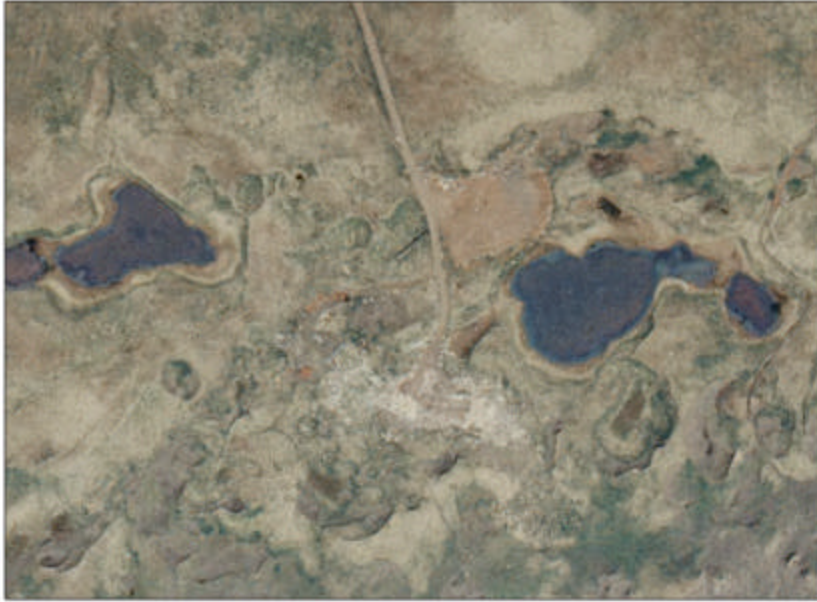
Photo 5 Former Landfill (Tract 42). Quadrangle Aerial Photograph. Note Image is Oriented with Due North at 12 O'Clock. U.S. Geological Survey. 1993.

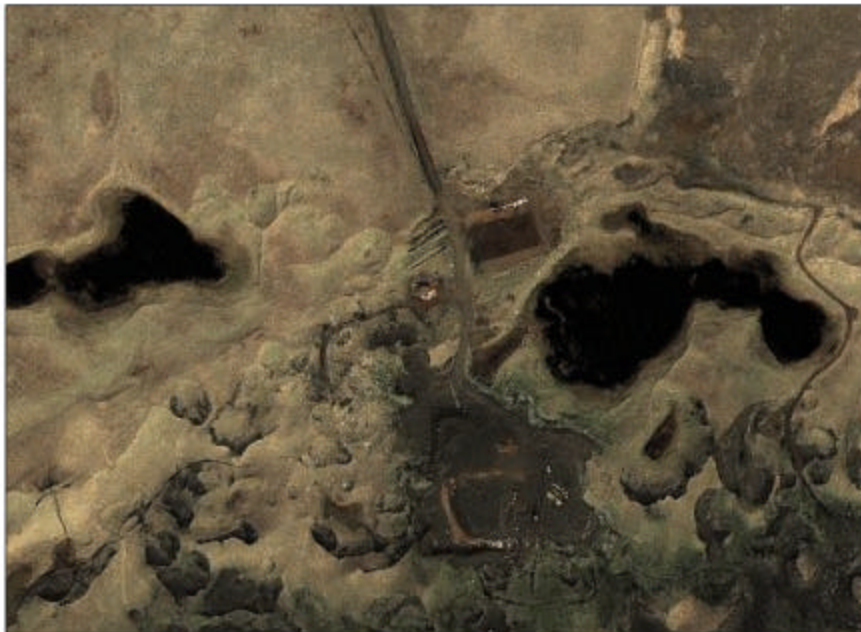
Photo 6. Former Landfill (Tract 42). IKONOS Satellite Image. Note Image is Oriented with Due North at 12 O'Clock. Space Imaging, Inc. 2001.

- **2001.** This IKONOS satellite photograph shows the subject property during its active use as a landfill and before closure activities began. No features of interest are apparent.
